INSTALLATION RESTORATION PROGRAM

COLORADO AIR NATIONAL GUARD
BUCKLEY AIR NATIONAL GUARD BASE, AURORA, COLORADO

REMEDIAL INVESTIGATION REPORT VOLUME I

August 1995

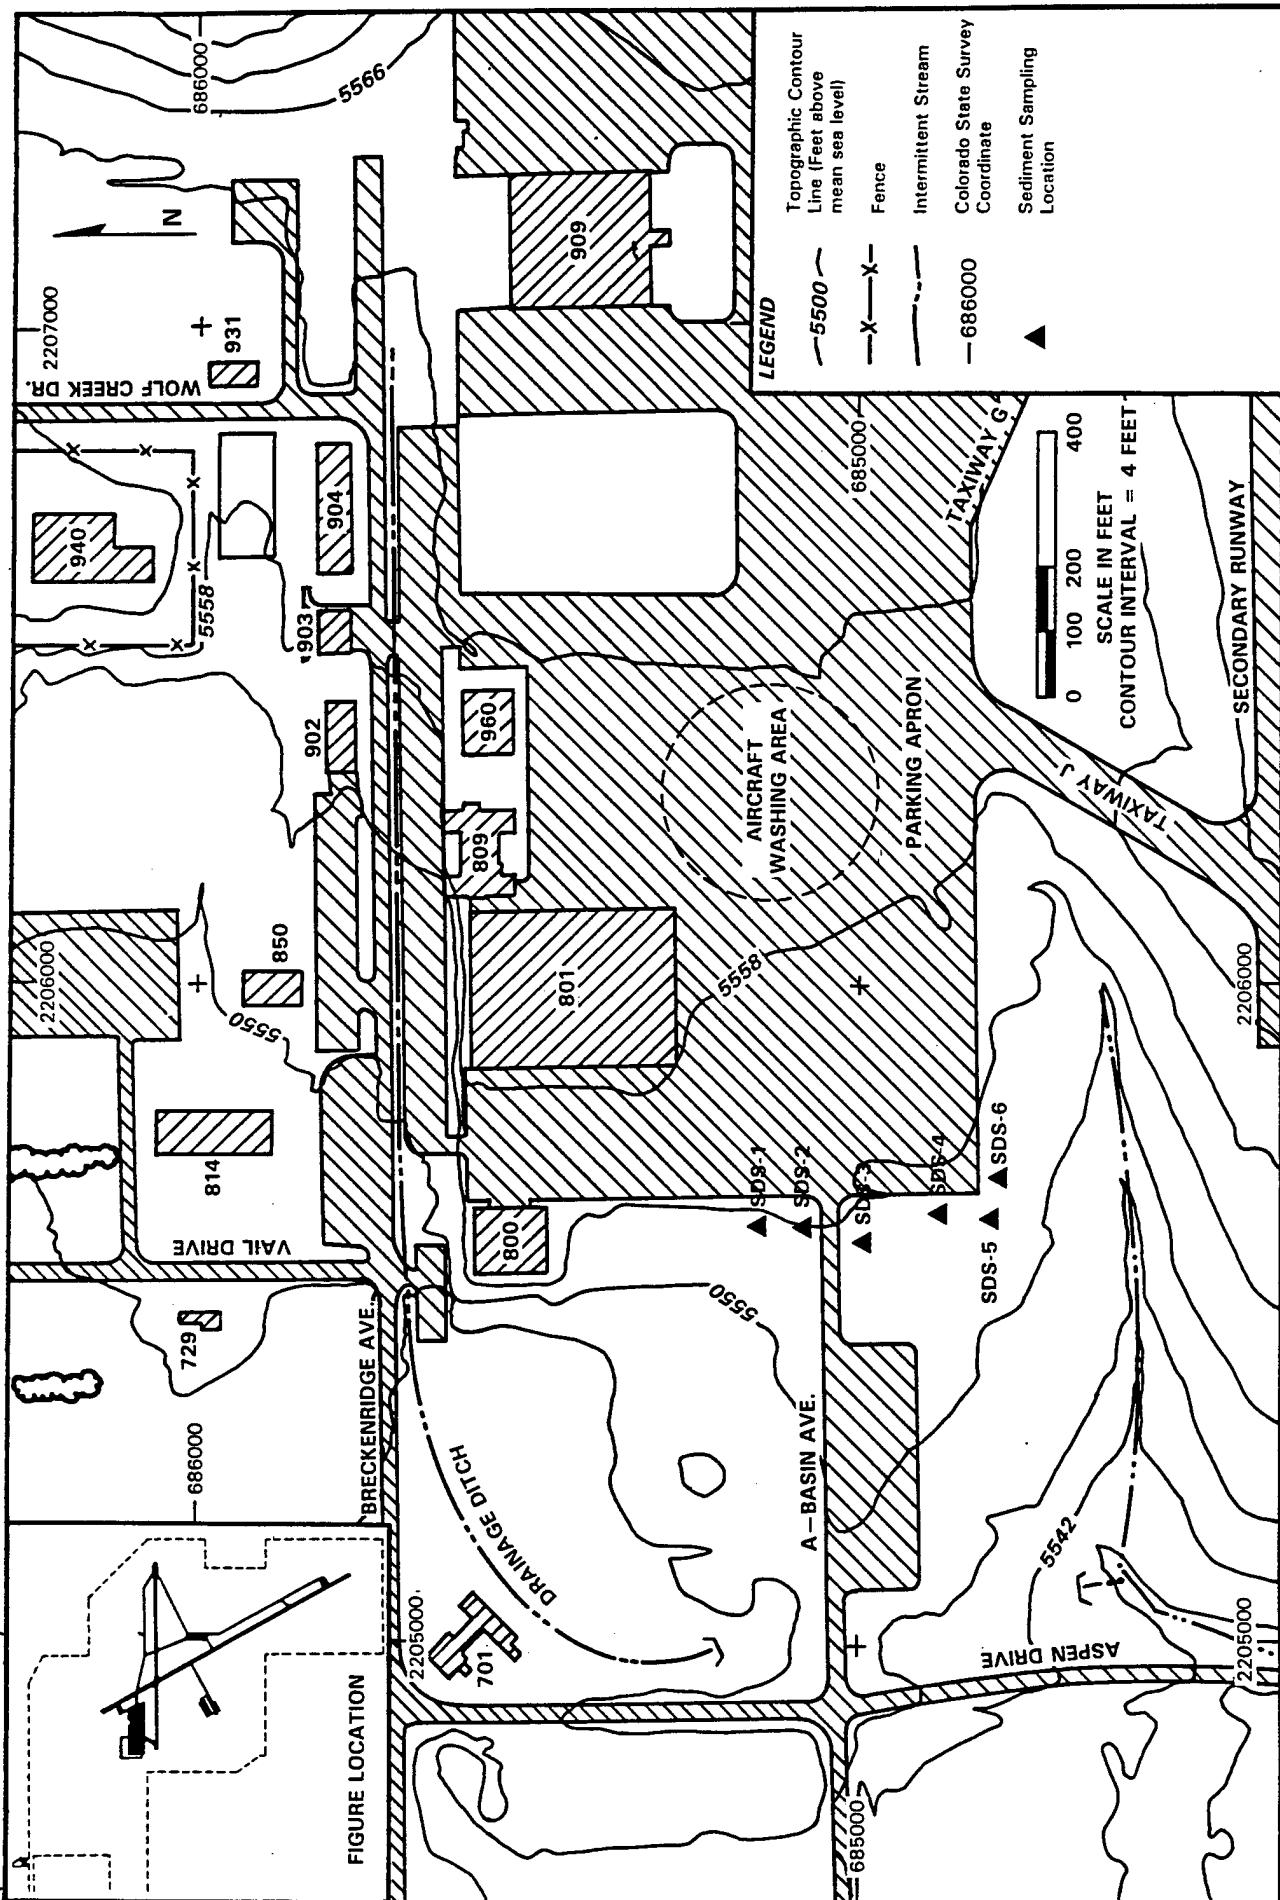
Figure 8-1 Field Activities for Site 5-Storm Drainage System, Colorado Air National Guard, Buckley Field, Aurora, Colorado

Six surficial sediments were sampled during the RI Part 1 at Site 5. The objective of sampling these sediments was to determine if contaminated paints, solvents, or other chemical compounds washed into the drainage system from the aircraft apron. The sampling locations are shown in Figure 8-1.

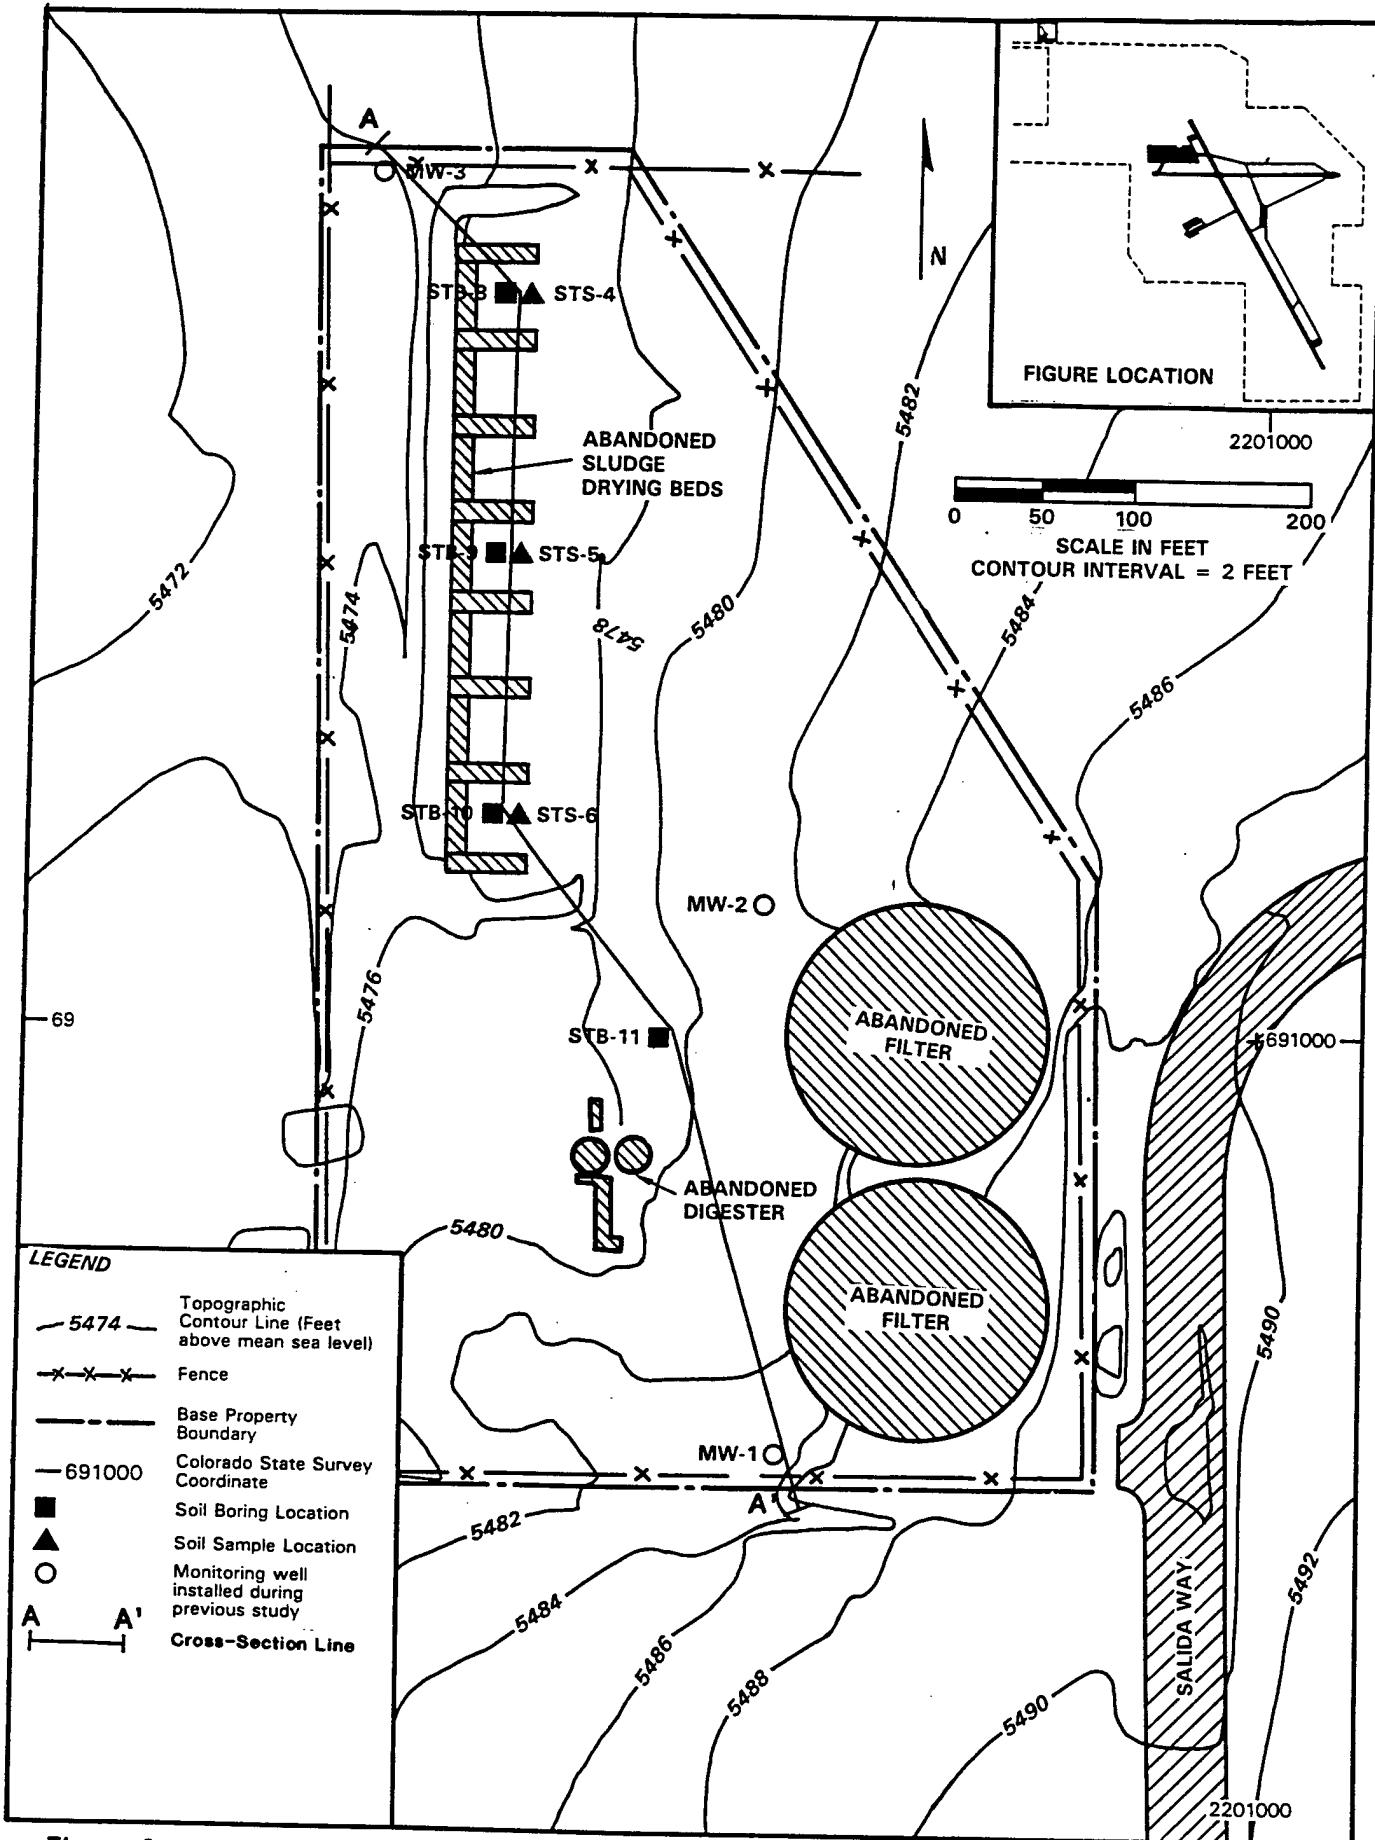
Figure 9-1 Field Activities for Site 6-Former Sewage Treatment Plant, Colorado Air National Guard, Buckley Field, Aurora, Colorado

Three surficial sediments were sampled during the RI Part 1 at Site 6. The objective of sampling these sediments was to determine if sludges discharged from the Former Base Waste Treatment Plant contaminated the surficial soils in the adjacent area. Figure 9-1 shows surficial sediment sampling locations.

Soils from four soil borings were sampled during the RI Part 1 at Site 6. The objective of the soil borings was to investigate whether soils in and under the sludge drying beds and soils adjacent to the sludge digester were contaminated and whether any contamination could be migrating deeper into the alluvial soils. Figure 9-1 shows the location of soil borings at Site 6.

Two previously existing monitoring wells (MW-1 and MW-2) were sampled and analyzed with the objective of determining if contaminants from the Former Sewage Treatment Plant have entered the groundwater under Site 6. Figure 9-1 shows the location of the two monitoring wells.

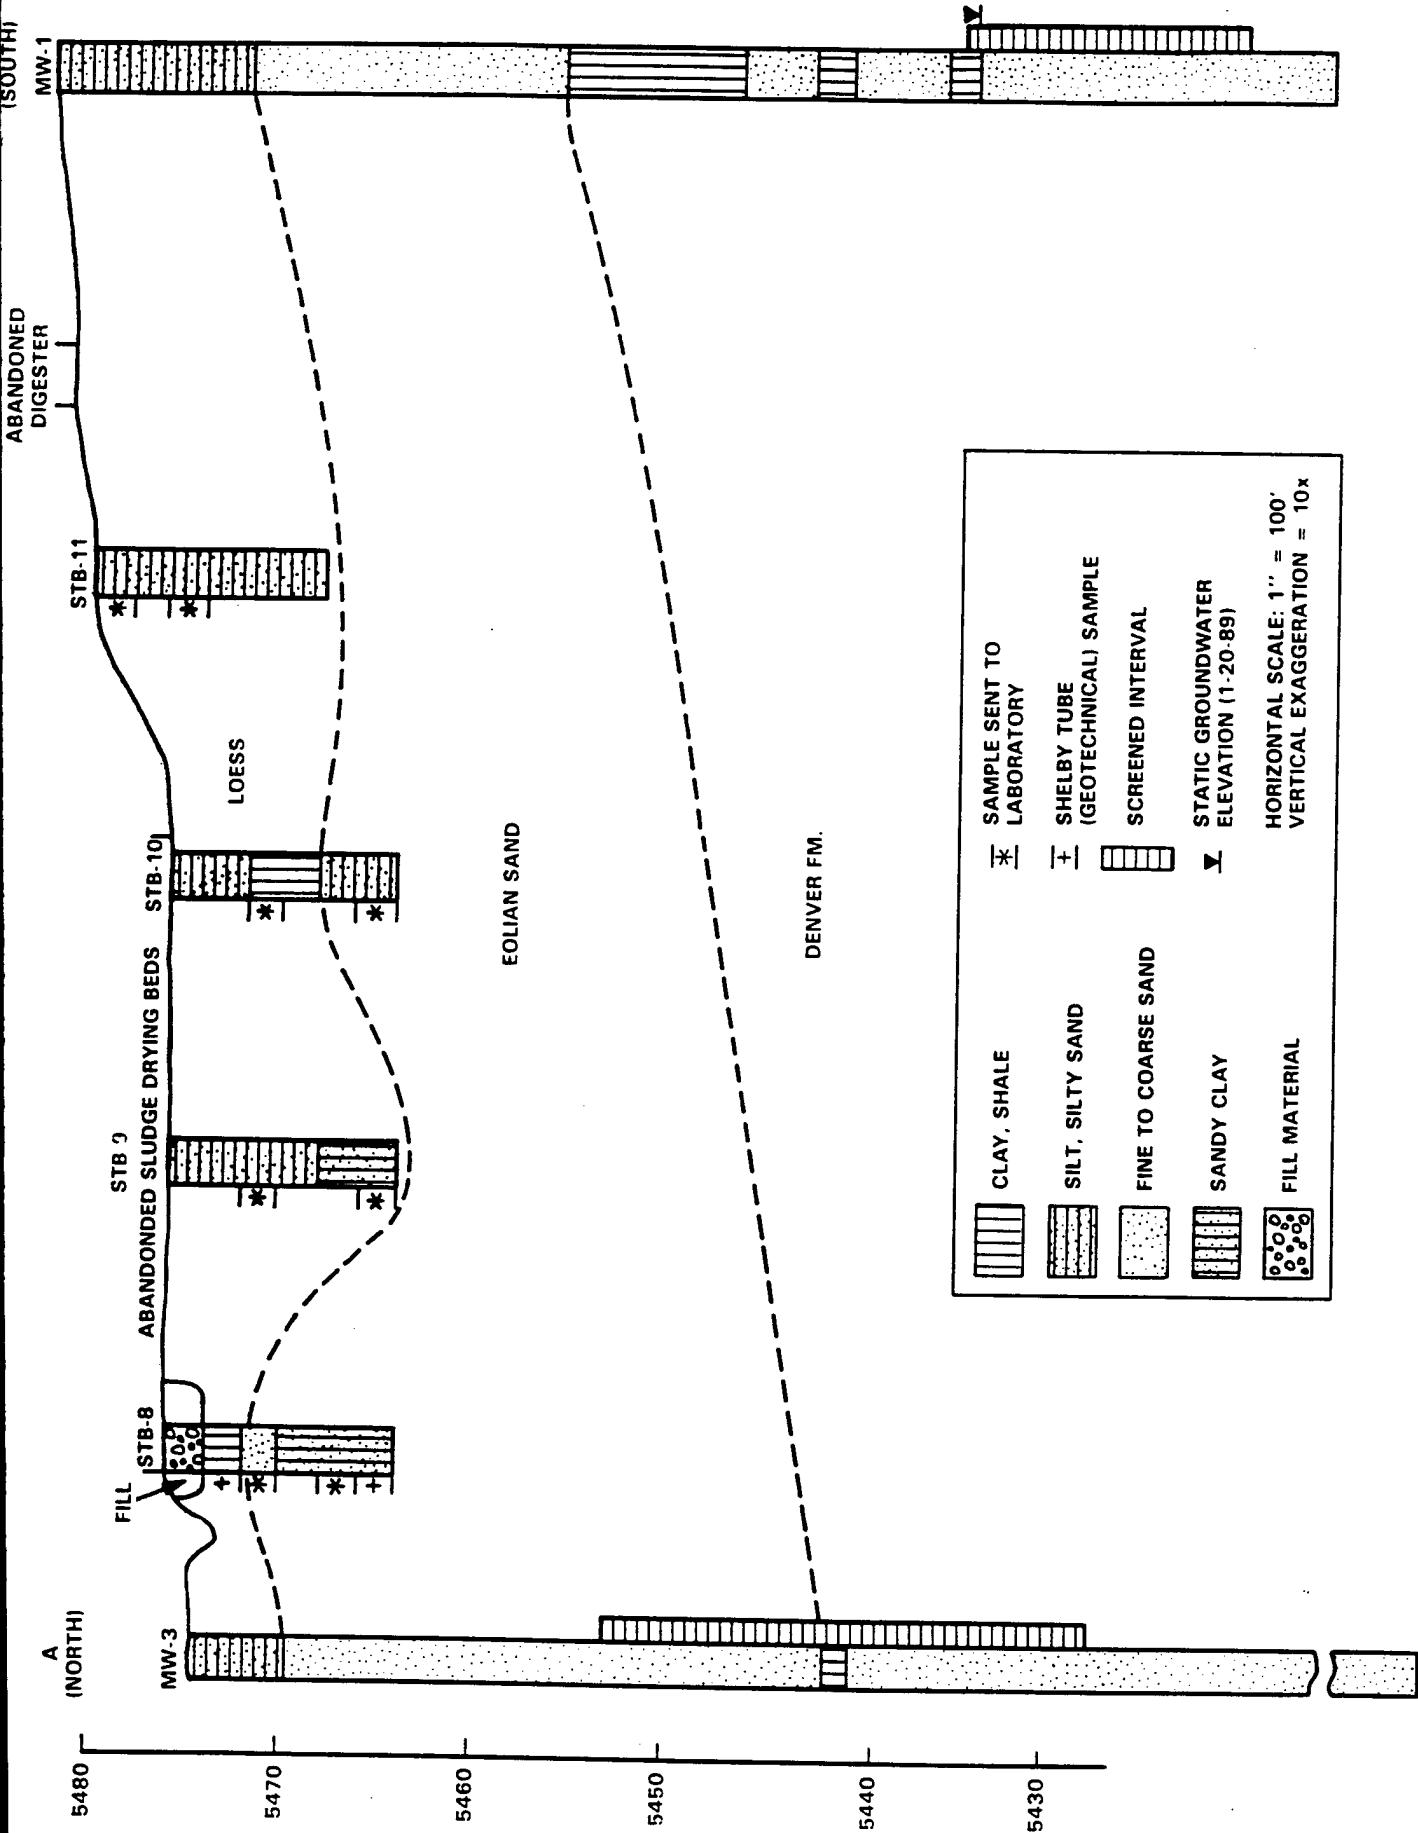
Figure 9-2 Generalized Geologic Profile A-A' of Site-6 Former Sewage Treatment Plant, Colorado Air National Guard, Buckley Field, Aurora, Colorado.

Figure 9-2 depicts a geologic profile through Site 6 - Former Sewage Treatment Plan. The sediments encountered during drilling at this site consist of a surficial 5-ft loess deposit underlain by silt, sands, and clays of the Denver Formation. Water levels are nearly 50 ft BLS, the deepest anywhere studied on the Base. Groundwater flow directions cannot be determined because one of the previously installed wells was dry, but there is a component of groundwater flow in the northwesterly direction based upon measurements within the other two existing wells. No other hydrologic data is available for this site because of the existing wells small size and generally poor condition.
